Timber survey for buildings at

WINGFIELD STATION, DE55 7NY

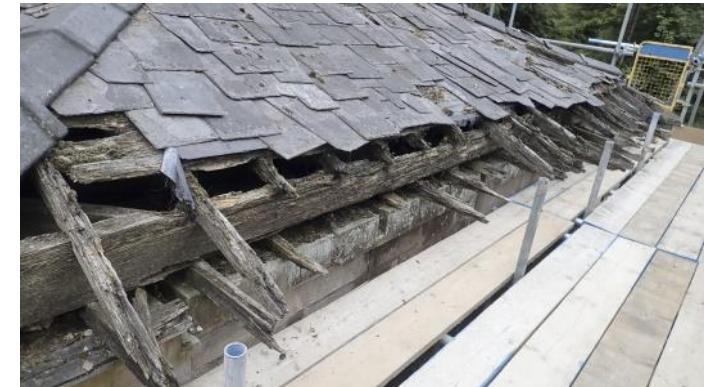
Photo 535 showing the eaves detail on the E elevation. This is representative of the 'average' condition of the timberwork external to the rafter plate – some areas better some worse. It will not be possible to make a complete assessment of the level of replacement until the roof is stripped. However it is likely that at least 75% of the rafter feet and soffit joists will require replacement, along with most of the rafter plate and inner joint plate.

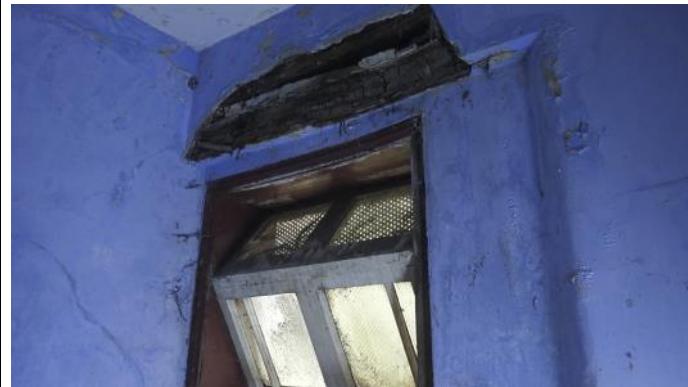
1
Photo 506. W04. The window surround and associated architraving is historically decayed and will require replacement. The sashes will probably be suitable for reuse.

The lintel and plate above (possibly a rafter plate or wall plate) are completely decayed above the window.

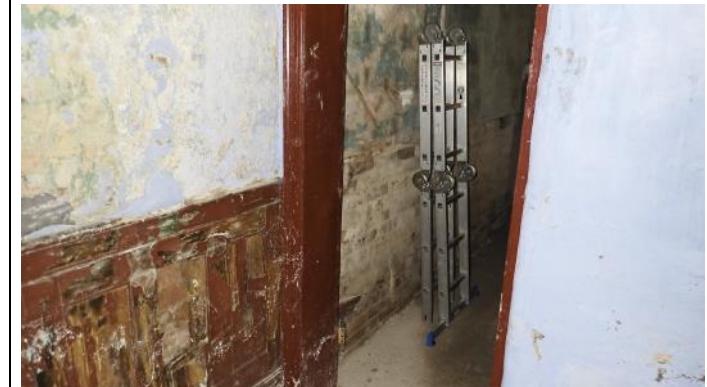
2
Photo 507 showing timber wall panelling which is completely decayed due to historic wood borer damage and fungal decay together with the lower sections of the door architrave immediately adjacent.

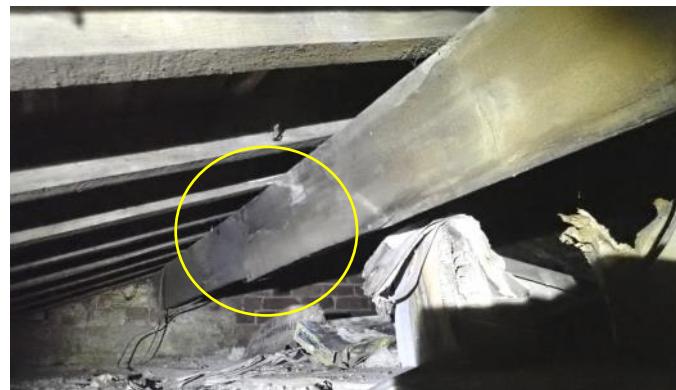
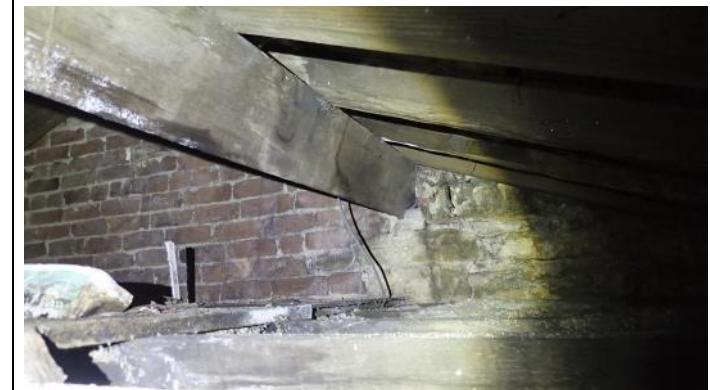
4

Photos 540 and 543-The purlin bearings were inaccessible but due to appearance-**assume they are both decayed in the wall.**

The W purlin appears fractured approximately 1 – 2 metres from the wall.

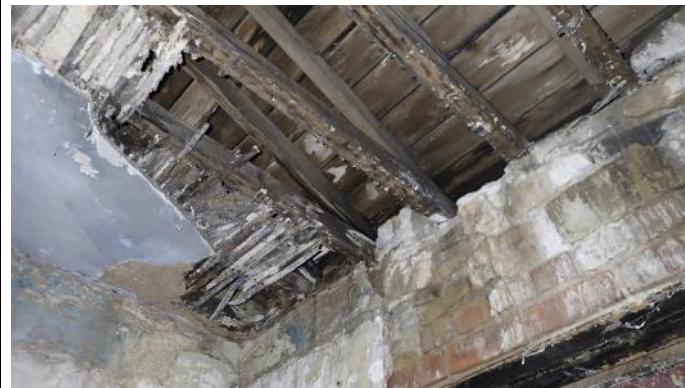
Photo 513 showing current water ingress which has caused decay to the ends of five ceiling joists. Allow for decay to 5 rafter ends together with the associated rafter plate and sarking board.

The remainder of this void looking S along this roofline appears to be generally sound.

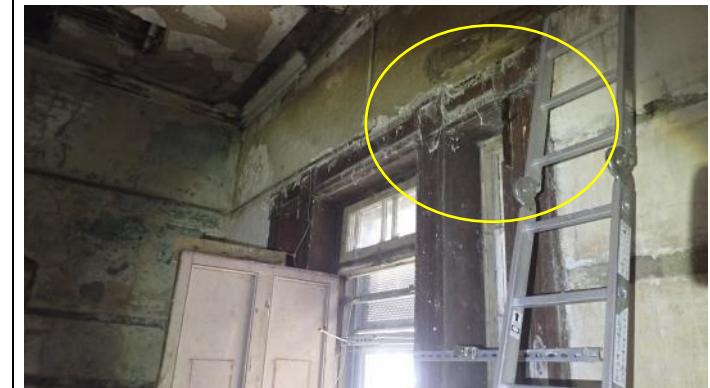
6

Photo 515. W01 – W03. There is a concealed timber lintel above which is completely decayed in its bearing. The head and upper sections of the architrave are also historically decayed. The lower sections where in contact with the ground are also decayed locally. The decay to the architrave is most severe at the S end, for approximately 1 m radius from the upper corner – circled.

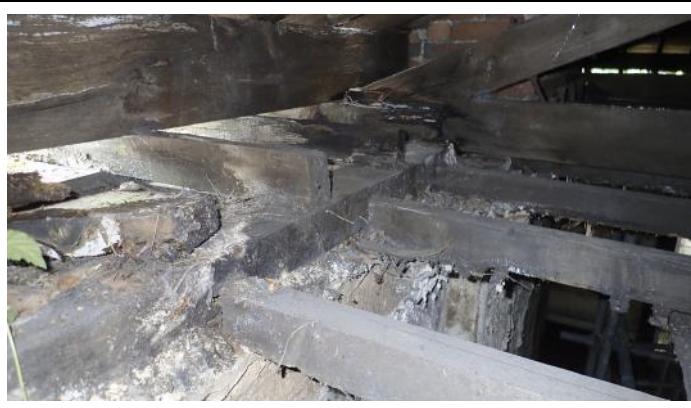
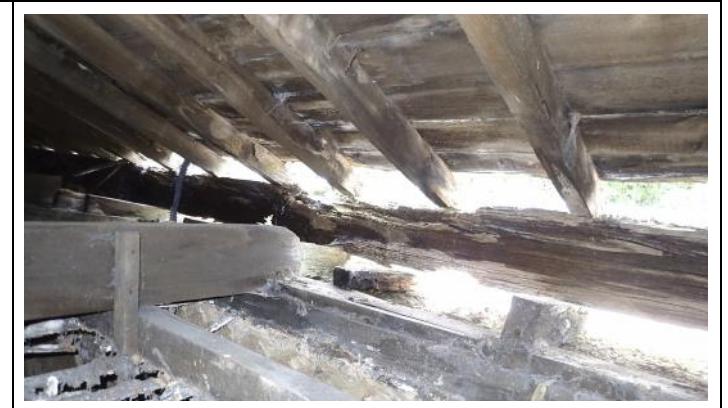
<p>7 Photos 544 and 546 showing the S and E elevations of the central section of roof. The inner plate has decayed historically together with the ends of all ceiling joists in contact with it. The soffit timbers have decayed to varying extents, although it is probable most will require complete replacement. The rafter plate is now extinct or severely decayed and will require replacement. The ends of all rafters in contact with it will require support.</p>

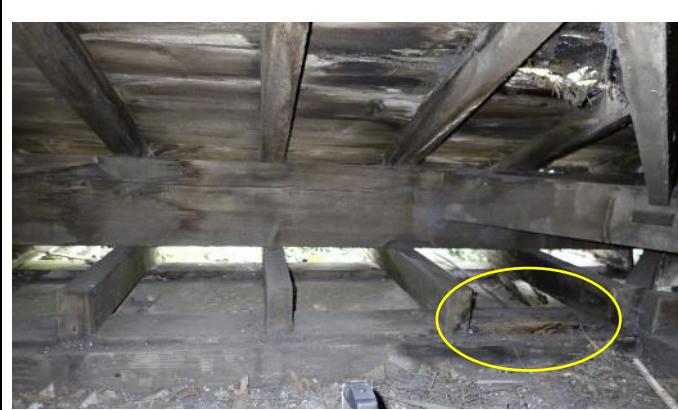
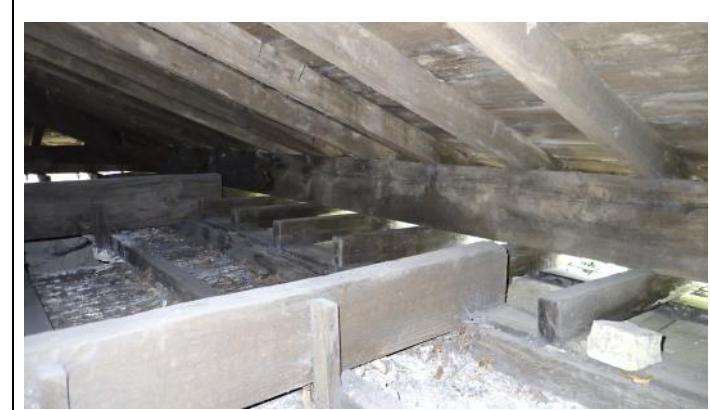
12

Photo 550 and 552 showing the W elevation of the central roof. The rafter plate is in good condition as are the bases of the hips and dragon beams. **The inner plate is historically decayed at its N end – circled – as is the sarking above.**

Not all of the brackets are accessible where they are embedded within wall-head and extend out – although most of them seem to be decayed where they travel beyond the outer line of the wall together with the soffit timbers.

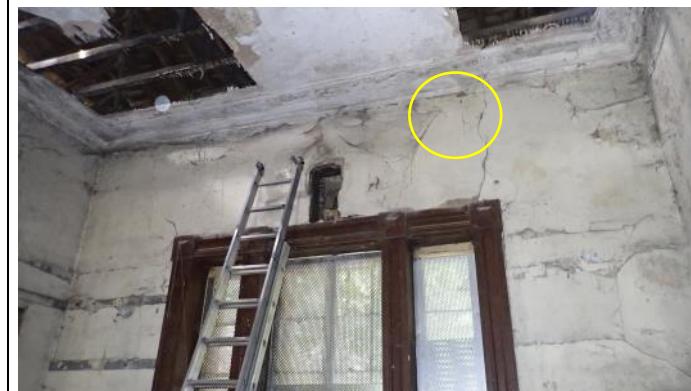
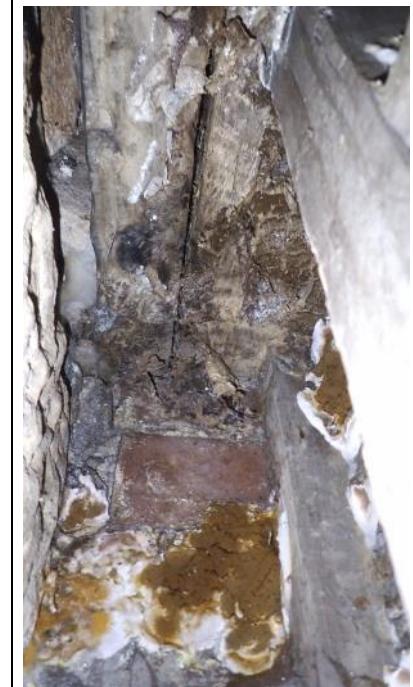
14

Photos 528 and 525 showing windows 07-09. There are no obvious signs of decay to the architrave. However, there are signs of active dry rot growth in the cavity or stud work immediately above the head of this tripartite window. There are signs of decay to the bases of the studs and what is possibly the lintel of the window opening. An area of plaster will have to be removed from above the window and it may be found that the window lintel and possibly other sections of the window frame and architrave are decayed in the middle of the wall.

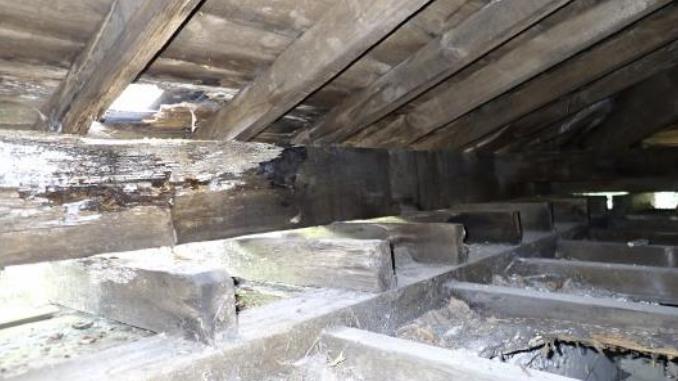
<p>15 Photo 549. Water ingress at the foot of the valley has caused localised decay to the rafter plate and rafter feet in contact with it.</p>

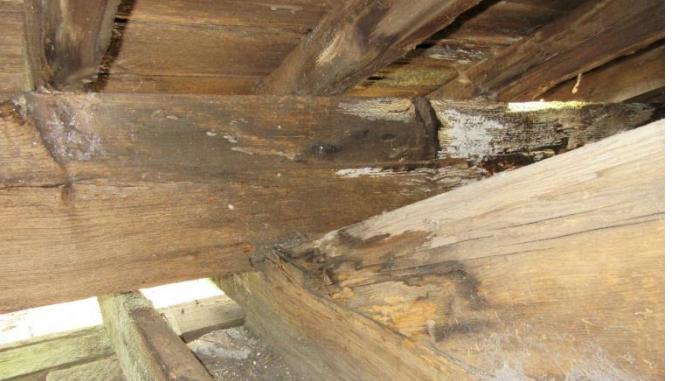
<p>16 Photo 705. The damage to the rafter plate and associated feet continues to the chimney. The S bearing of the W truss is sound.</p>

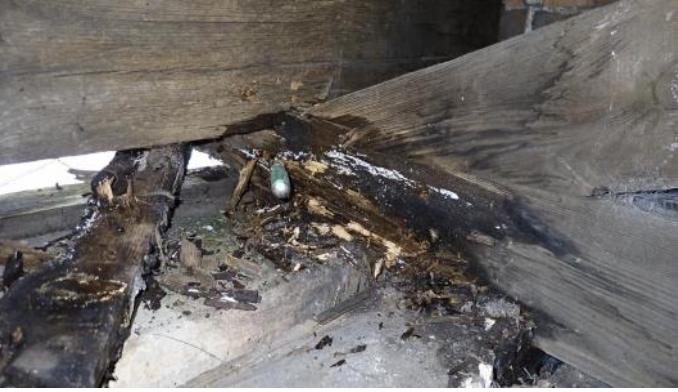
<p>17 Photo 547 shows the S bearing of the roof truss. The tie beam and principle rafter foot have been wet up locally and decayed down one side. That tie beam over the plate and below the principal rafter has lost approximately 25% of its section. If water ingress can be stopped relatively soon, decay should stop and the elements could be reused.</p>

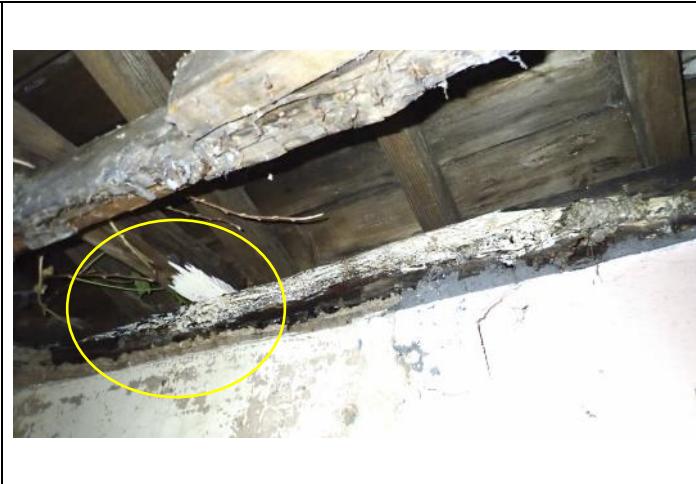
<p>21 Photo 530. The foot of the rafter is decayed where in contact with the wall plate. The plate is decayed which supports the ends of the ceiling joists which are also decayed.</p>

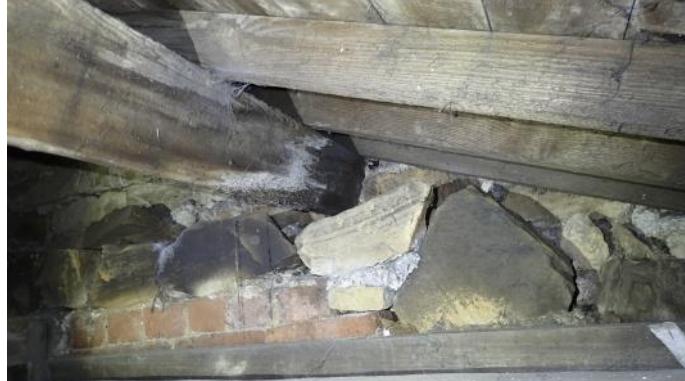
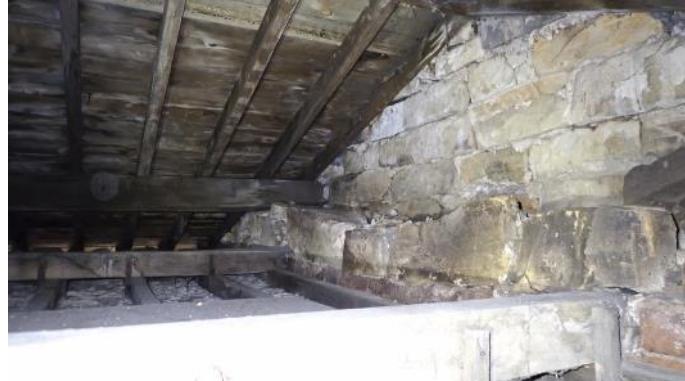
<p>22 Photo 539 showing very slow surface decay to the large section outer plate. There is a similar mode of damage to some of the rafter feet also, where decay extends approximately 10 mm into the surfaces of the timber but does not travel directly through its section. As elsewhere, the inner small section wall plate has decayed together with all of the visible ceiling joists in this area.</p>
<p>23 Photos 563 and 561 show the purlin bearings-they were inaccessible - but assume they are decayed in their bearings.</p>

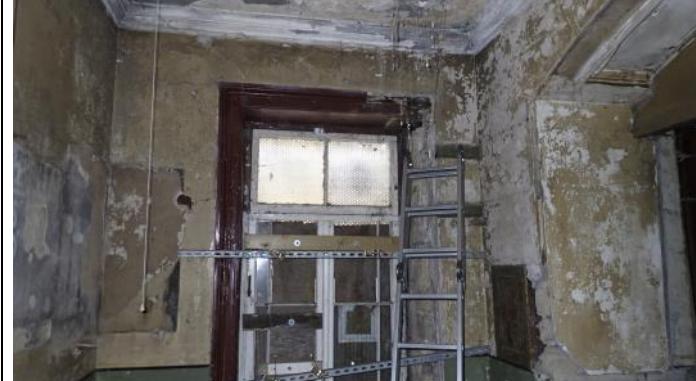
<p>24 Photo 517. Window 13. All of the architrave is either extinct or decayed. The lintel is decayed in the wall. The frame will require replacement and the sashes will be suitable for reuse.</p>

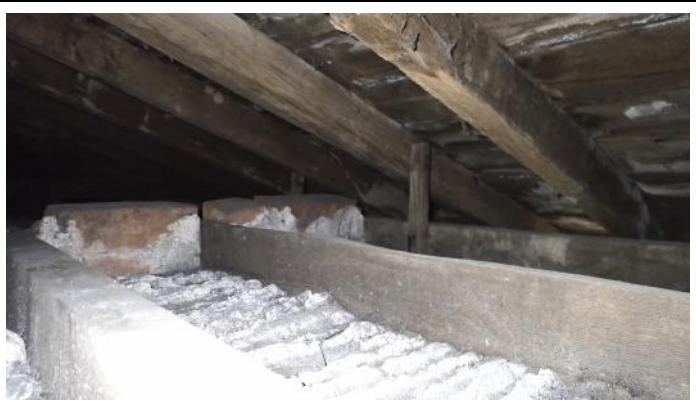
<p>26 Photo 568. Access into the roof was not good – although photos indicate the condition of the elements is good.</p>

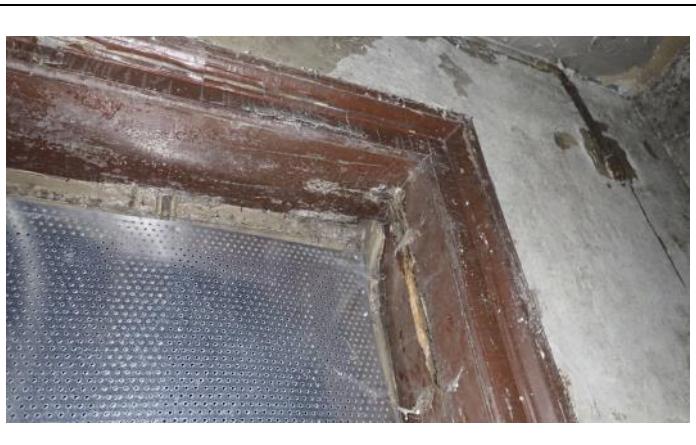
<p>27 Door 4 All architrave and lintels associated with this opening are decayed. The door has some damage but would be suitable for reuse. Again, all embedded timber at dado is decayed along with all wainscot panelling.</p>
<p>28 Photo 518. The architrave is decayed and will require complete replacement. The lintel is historically decayed in the wall. The sashes seem to have some interesting detailing at the heads but were inaccessible due to the security mesh.</p>

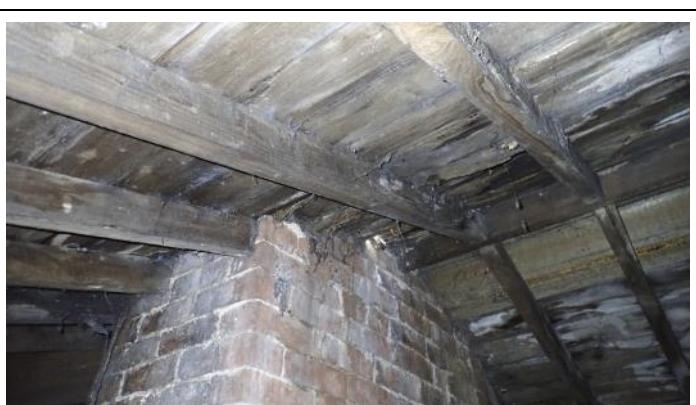
<p>29 Window 10. The architrave is decayed as is the lintel, although again the sashes should be suitable for repair and restoration although were generally concealed by the security mesh.</p>
<p>30 Photo 564 showing the roof cut around the chimney. There is localised decay to the timbers and sarking where they interface with the chimney.</p>

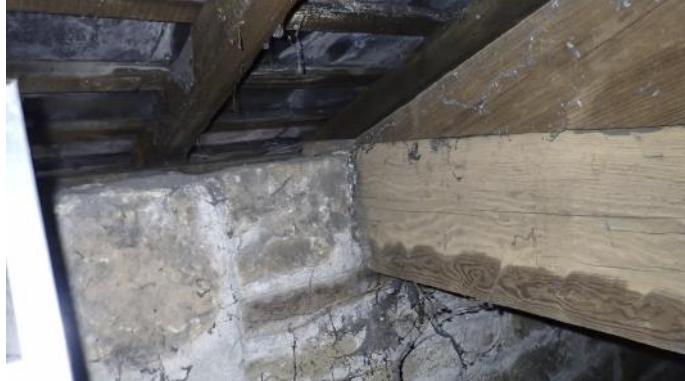
PARCEL OFFICE			
31 Photo 574 showing the S ends of the E trusses which are sound in the wall. There is some loss of sapwood to the lower edge of the embedded bearer plate to furniture beetle, although this is not significant. The outer rafter plate and rafter feet are sound.

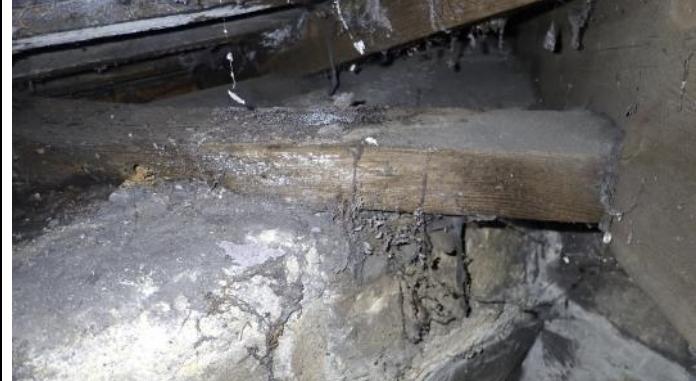
32 Photo 576 showing the decayed end of the dragon beam in the SW corner that will require replacement.

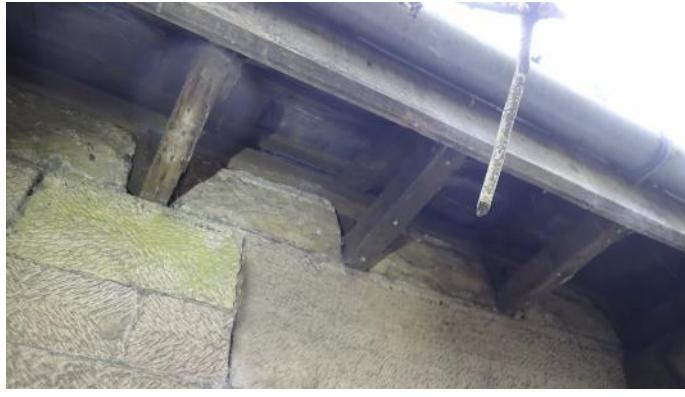
33 Photo 569 shows some form of support for the soffit timbers on the S elevation where the soffit timbers seem to be wedged in with other timbers in the wall as opposed to the arrangement on the W and E elevations (photo 570) where the soffit timbers seem simply embedded.
