WINGFIELD STATION

SOUTH WINGFIELD, DERBYSHIRE

The Station, designed by Francis Thomson, was built in 1840 for the North Midland Railway. It was closed in 1967 and sold in 1979. Paint samples were taken from interior and exterior surfaces to find out how it was decorated originally, and how it was treated in the years that followed.

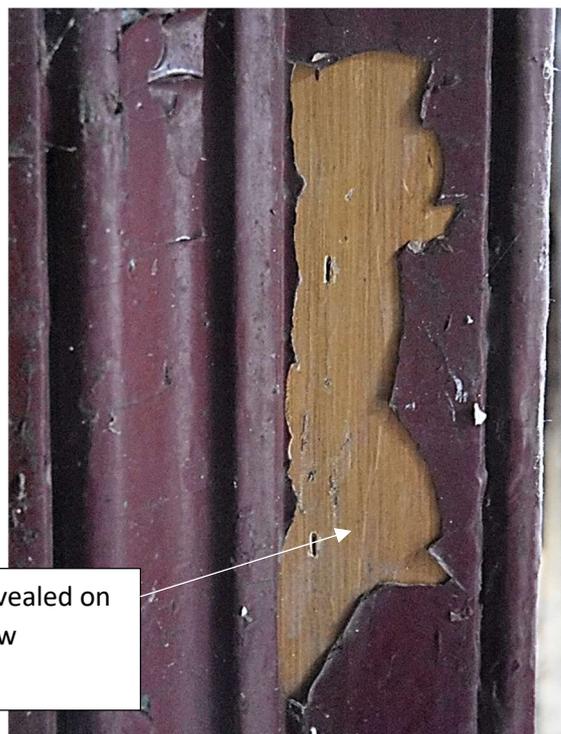
The graining involved a cream-coloured ground layer, very thin brown glaze for the 'grain' pattern and a clear varnish [Sample F1, p.24]

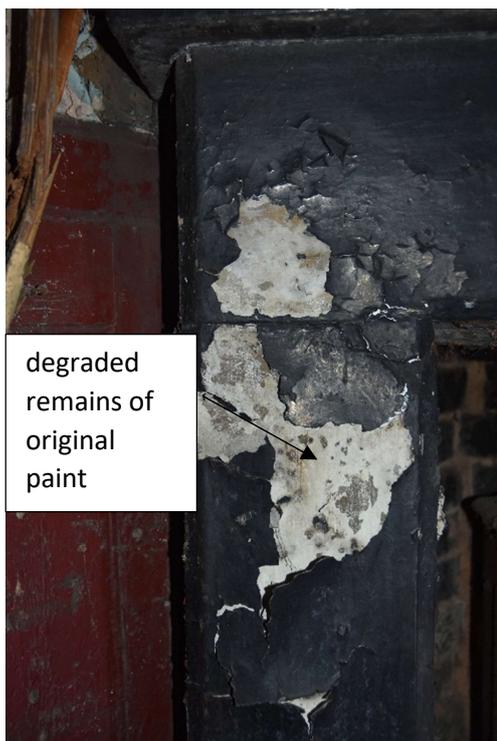
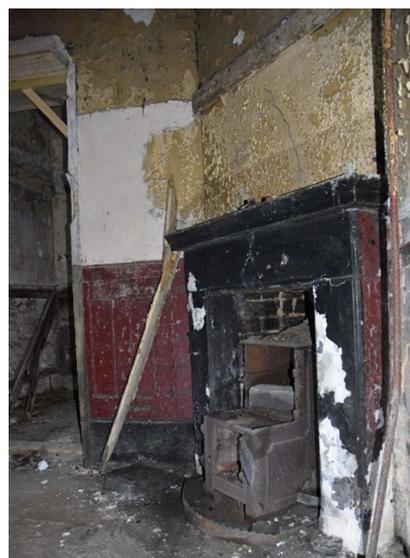
Where later layers have flaked off a powdery pale paint scheme can be seen on the stone. This is the remains of the original scheme [Sample F6, p.24].

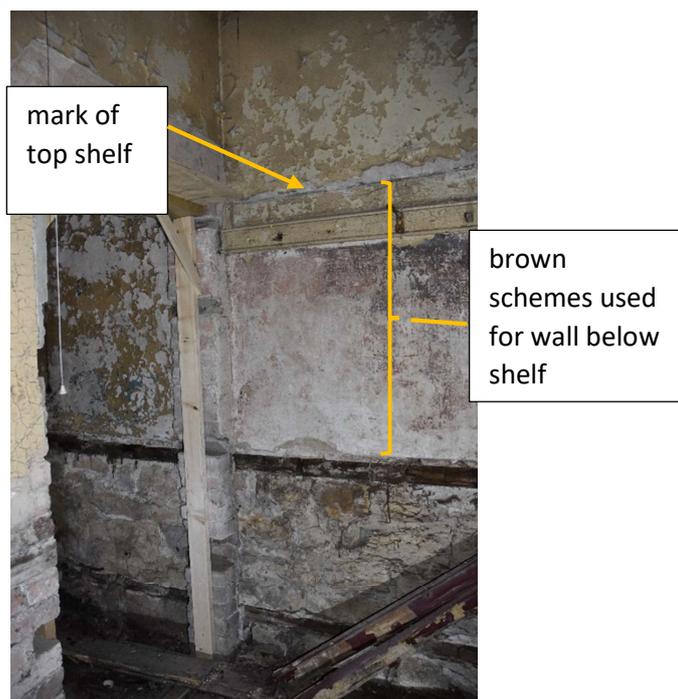
We can see today, where later layers have flaked off, how those dark brown schemes on the walls extend only up as the shelf mark

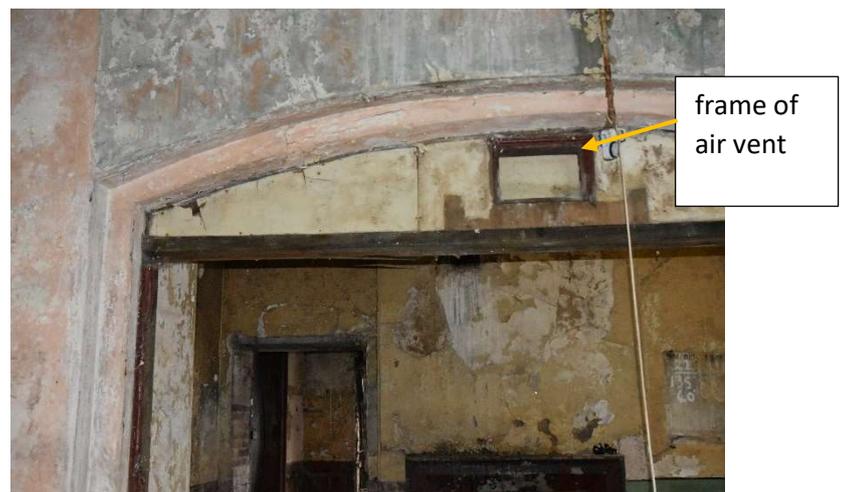
An air vent set into the upper part of the opening suggests the archway was filled in.

The paints used for this vent, were not ones used on the walls, so there is no direct colour comparison with other features, but it has just three lots of lead-based paint on it [Sample B13, p.28], and the insertion of the rails was followed by three lots of lead-based paint on the walls [Sample A1, p.29]. Following the changes, the rooms were repainted.

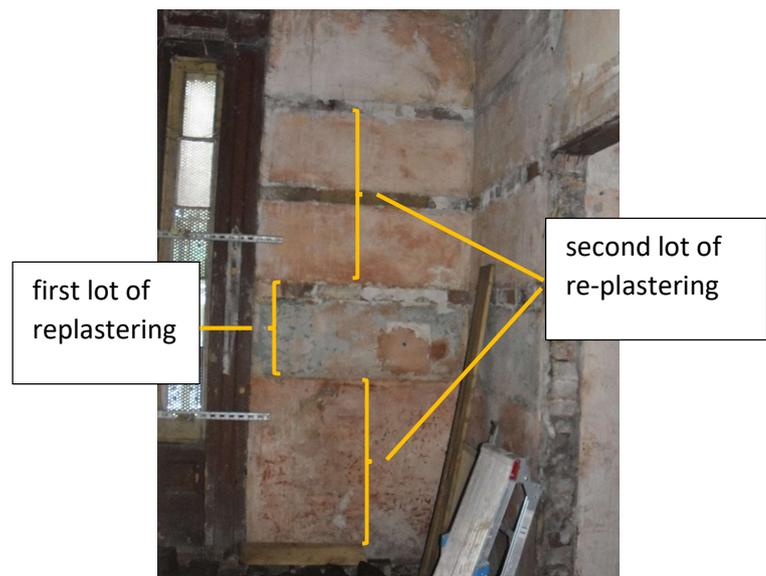
The first lot of replastering involved work on parts of the east and south walls of the Booking Hall and some of the rails, such as the one seen at the west end of the south wall, were replaced. The second lot of replastering involved work on the chimney breast in the Ticket Office.

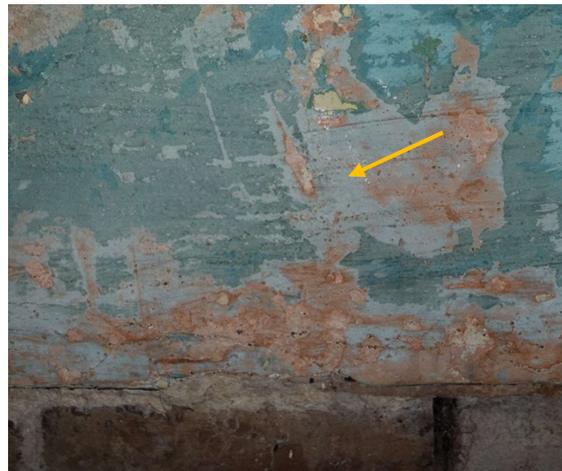
Patches of this bluish green can be seen today under later, darker green paints

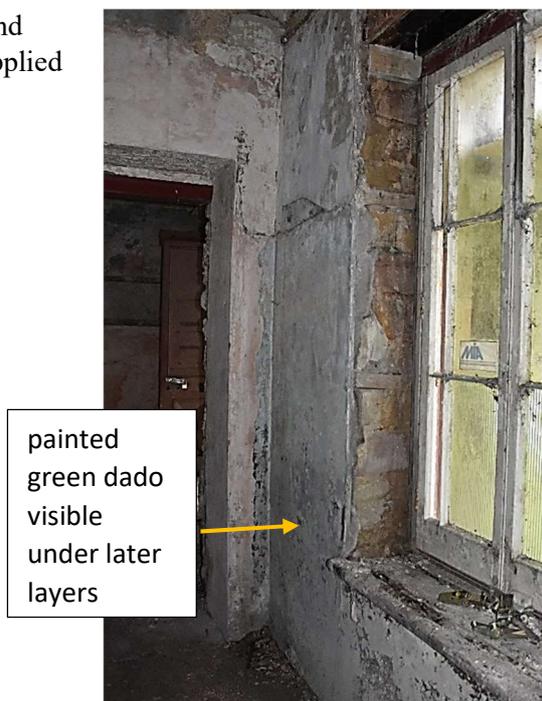
The scheme involved dark green paint on the dado and light green paint above. The same decoration was applied in most of the other rooms

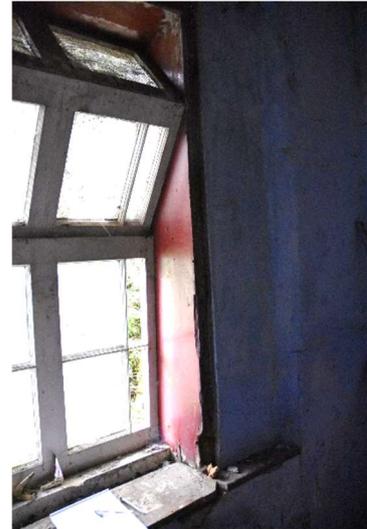
The upper part of the window, with its zigzag shape, appears to have been introduced at the same time. The paint was thoroughly stripped off the last time the room was decorated, but remains of a cream coloured zinc-based paint were found as a first scheme on the wood in one sample [Sample E4,p.33]

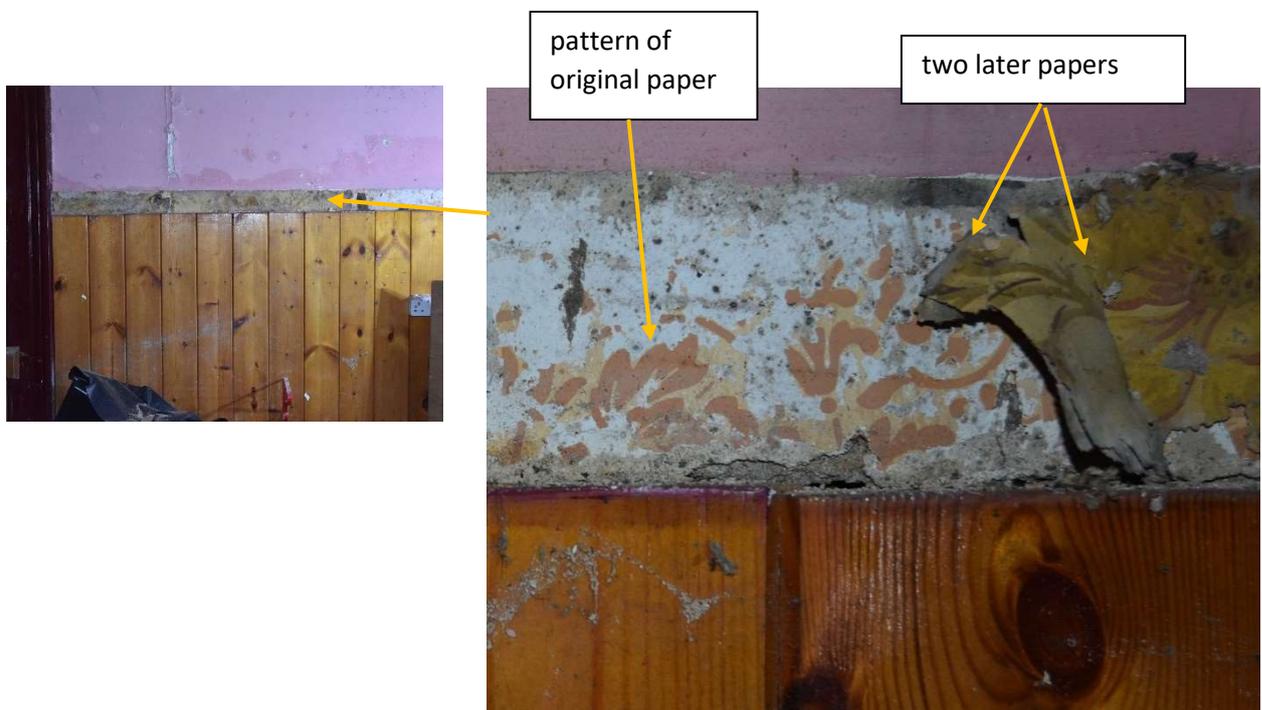
Printed wall paper was applied to the plaster walls. This was revealed when one of the later horizontal rails was removed.

The paper used was very thin, and glued directly to the plaster instead of to lining paper. It has now almost completely degraded, making it impossible to lift off a section. The paper was given a ground based on chalk which acted as the white background colour, followed by a floral motif executed in browns and yellows based on iron oxide pigments mixed with more chalk [Sample C21, p.34].

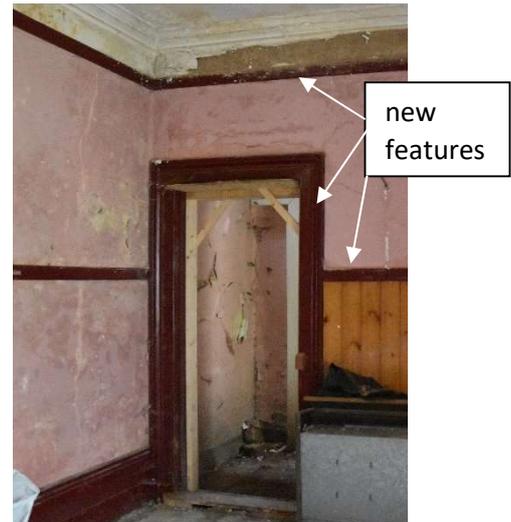
The wood of these features has since been stripped, but traces of lead-based paint were found. In one sample the paint also contained particles of red lead [Sample C3, p.34]

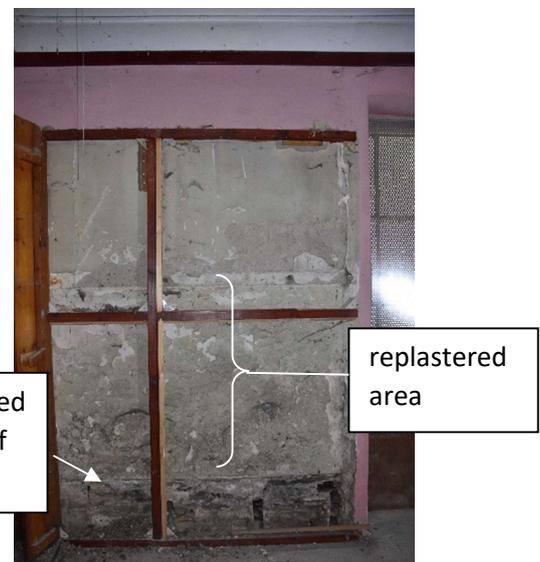
The lower part of the west wall, south of the window, was replastered as seen today, using gypsum plaster. The work suggests that something had been removed

The plastering was not well finished which may mean that wall papers were still being used. There was certainly still a skirting in place when this work was concluded because splashes of joinery paint were found on the lip in the plaster formed by the upper edge of the skirting.

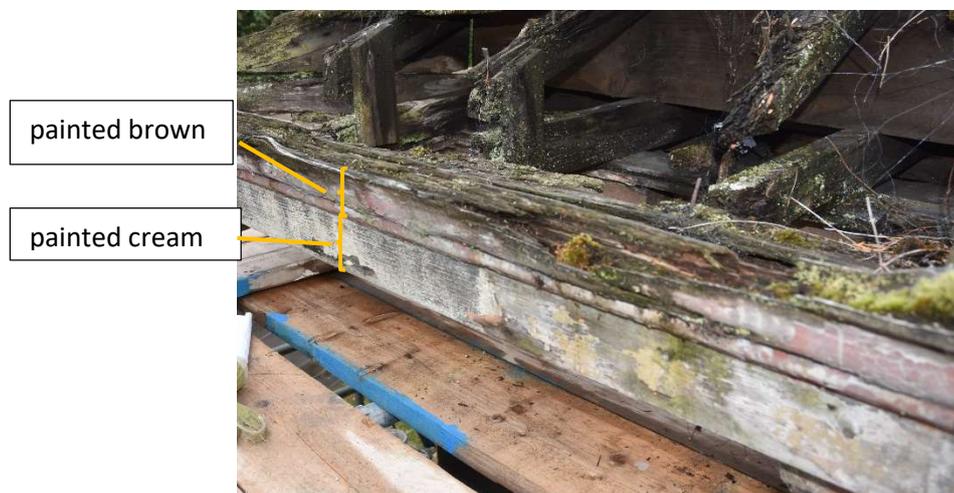
The dark cream colour was used for the soffits under the eaves, for the vertical part of the fascia boards and for the window casements.

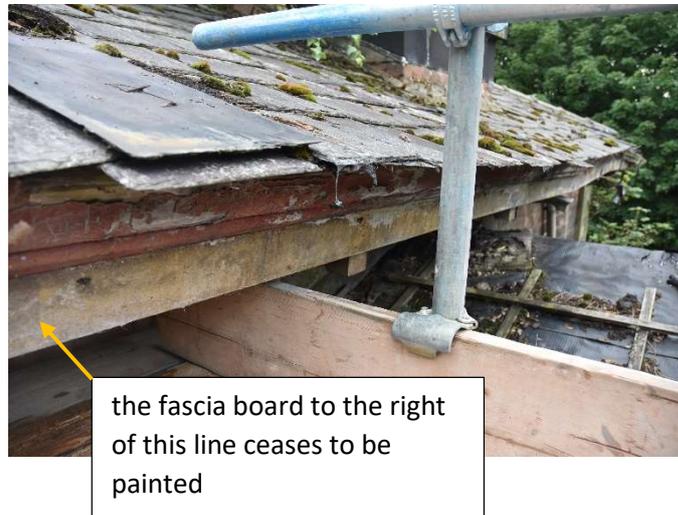
A very similar shade of brown started to be used for the woodwork inside the building at this time. When the change in colour scheme occurred, a cast iron gutter was fixed, using iron brackets, to the roof fascia board at the north end of the building, because part of this board stopped being painted [Samples Ex11 & Ex12, p.38].

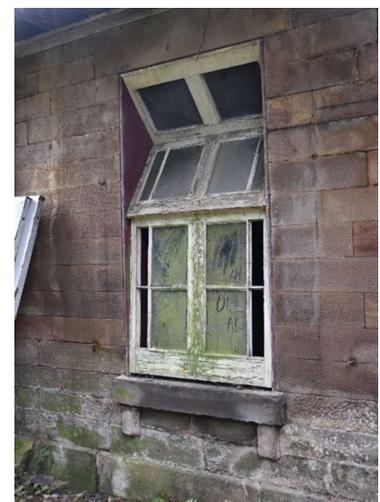
The windows at the south end of the building were worked on. The casements were stripped, and the zigzag upper part was either made new, or completely stripped because no trace of early paint was found.

The first paint found on the zigzag shaped upper part of these windows was based on zinc white, a pigment widely used in the inter-war period, and rarely after 1950 [Sample W2, p.35].

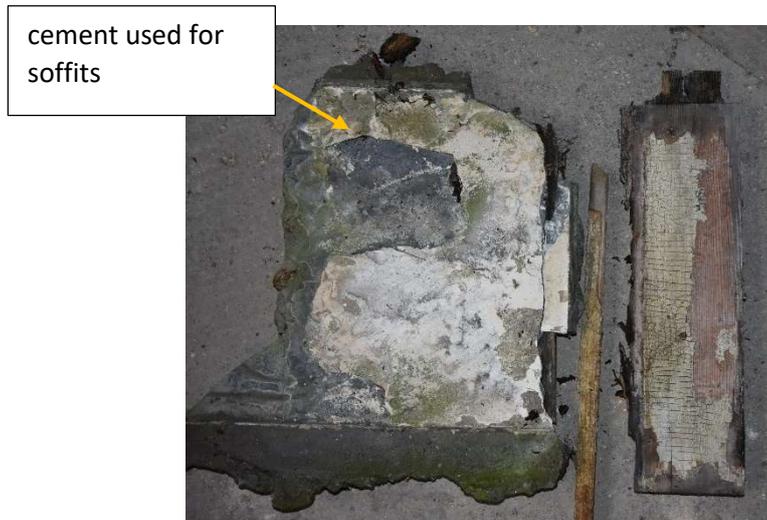
The same zinc-based paint used on the zigzag part of the south windows, was also the first paint scheme on the cement used in the soffits under the eaves. Here it was applied over a thin skim of gypsum plaster.

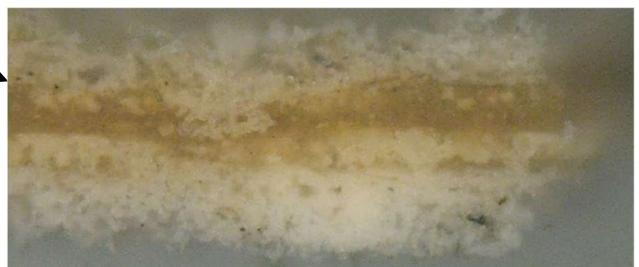
Fragment (ii)
First layers

The paint is damaged, but we can see a coat
of varnish over it which suggests graining,
or possibly marbling

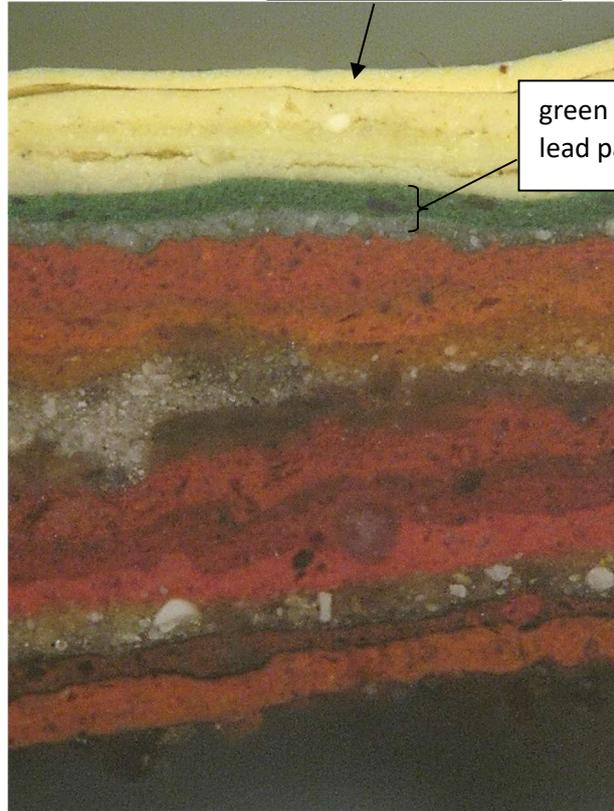
SAMPLE G5

green is last
lead paint

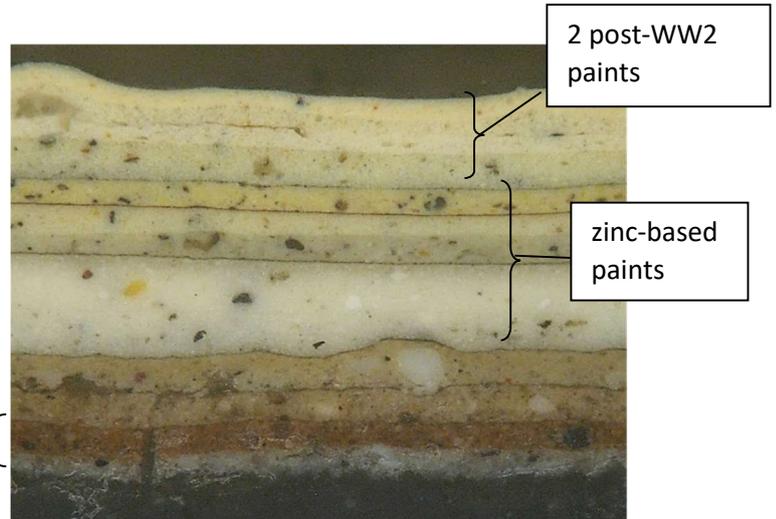
SAMPLE B13

The first scheme on the vent is the first of a series of browns used in this room – compare B34 below

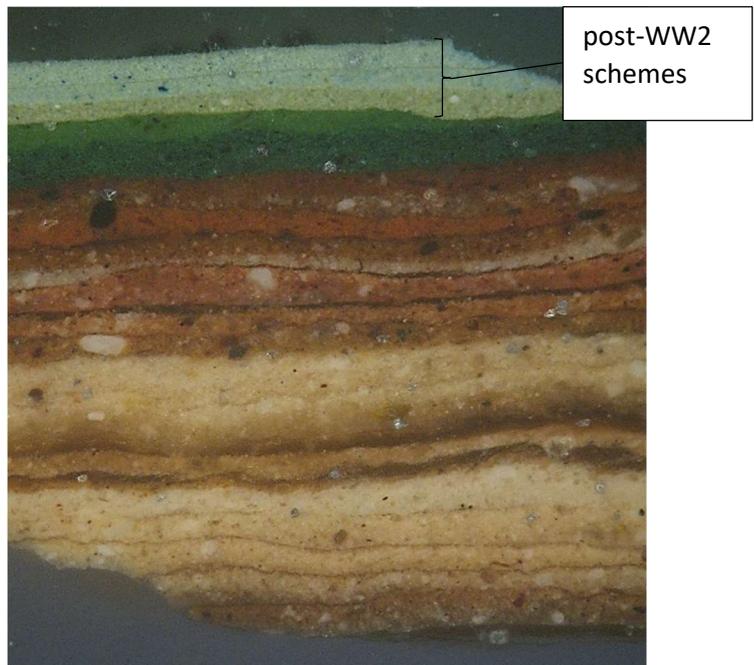
SAMPLE B3

Original scheme missing in this fragment, but all later layers present.

Showing the change from lighter tones to browns around the turn of the century

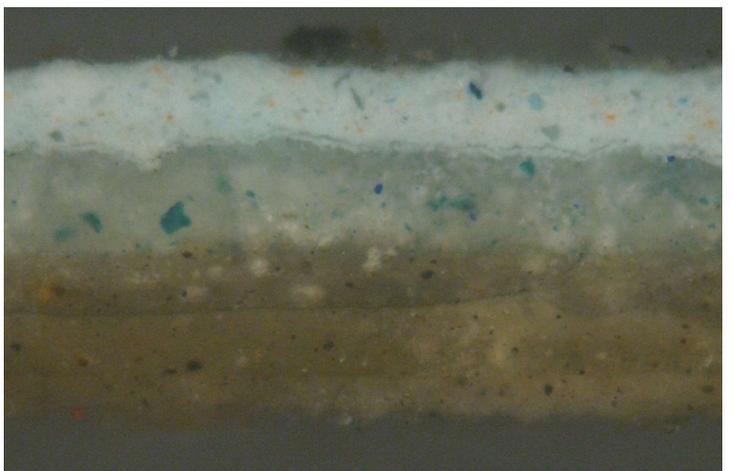
Showing the layers under the rail.
The sequence stops with the
pale blue oil paint

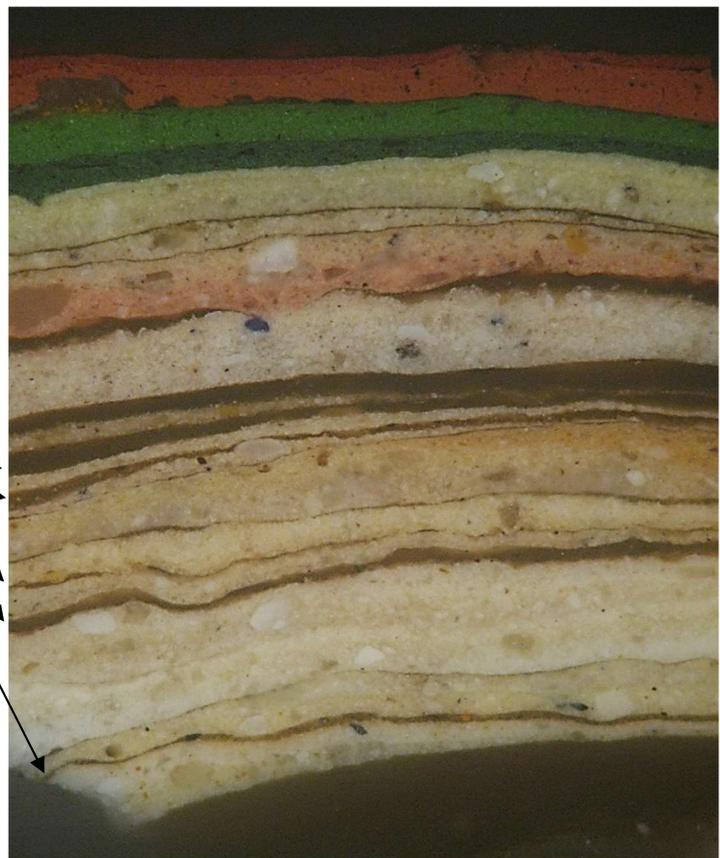
SAMPLE A5

The early C20th brown schemes are missing in this fragment, but it clearly shows the graining schemes used in the C19th

varnish layers
associated with grainings

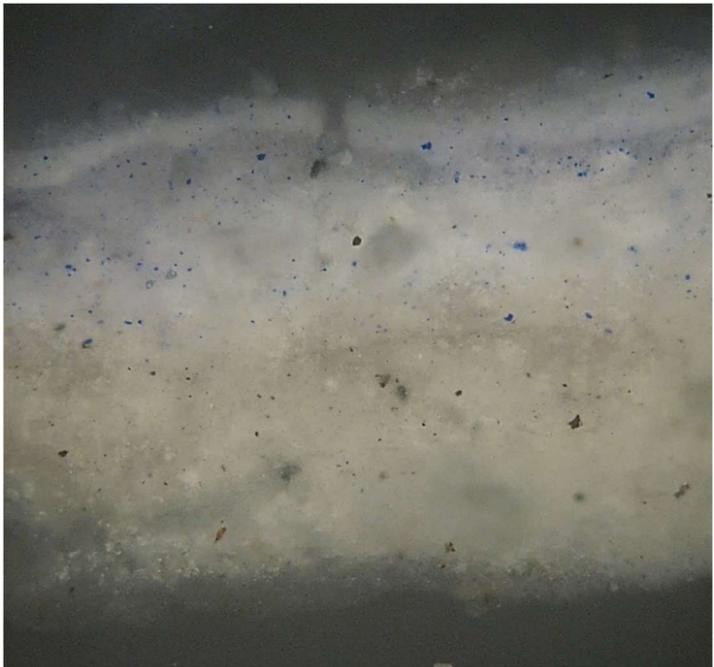
SAMPLE A22

The pigment in the blue is ultramarine

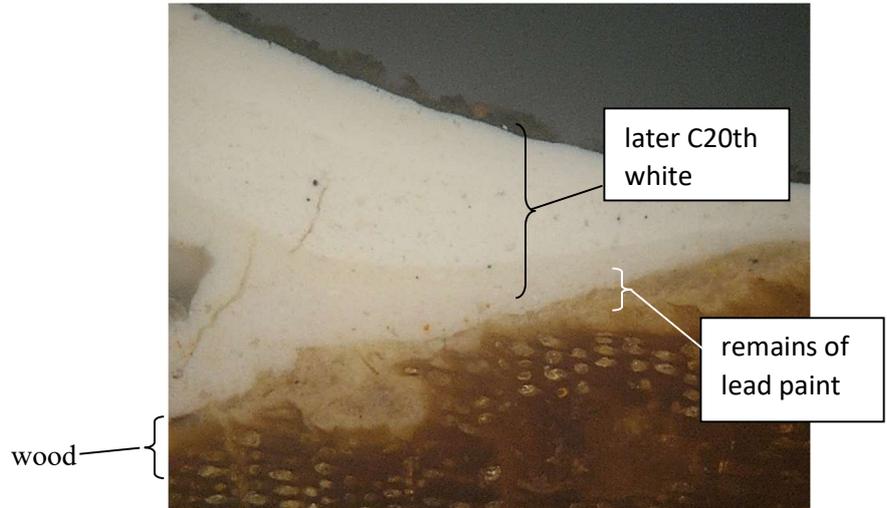
SAMPLE D1

The window was stripped the
last time the room was
decorated

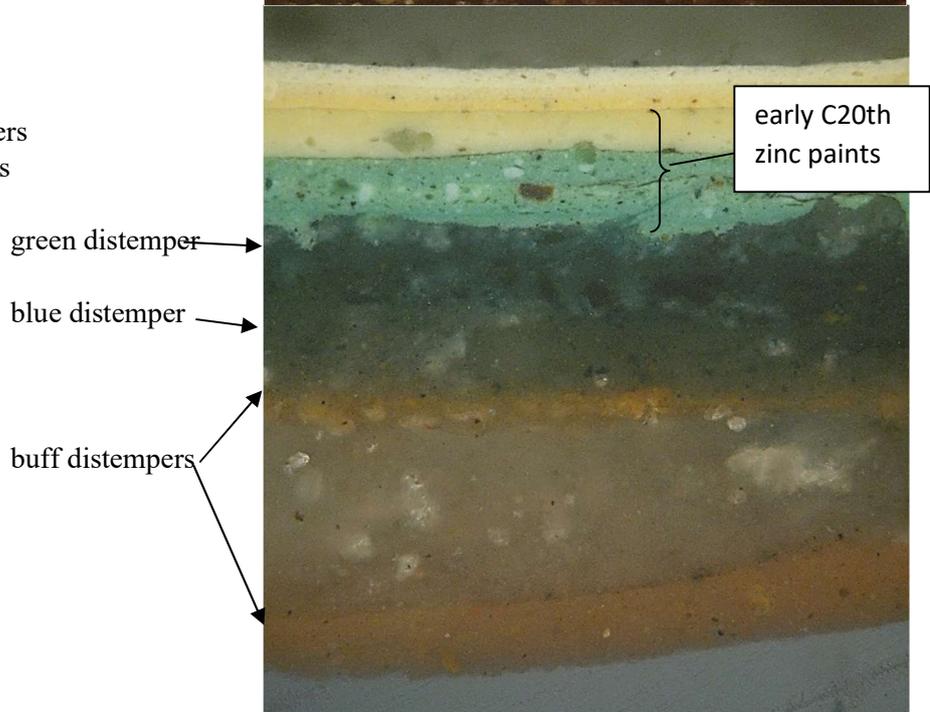
SAMPLE D3

Showing early distempers
under most recent layers

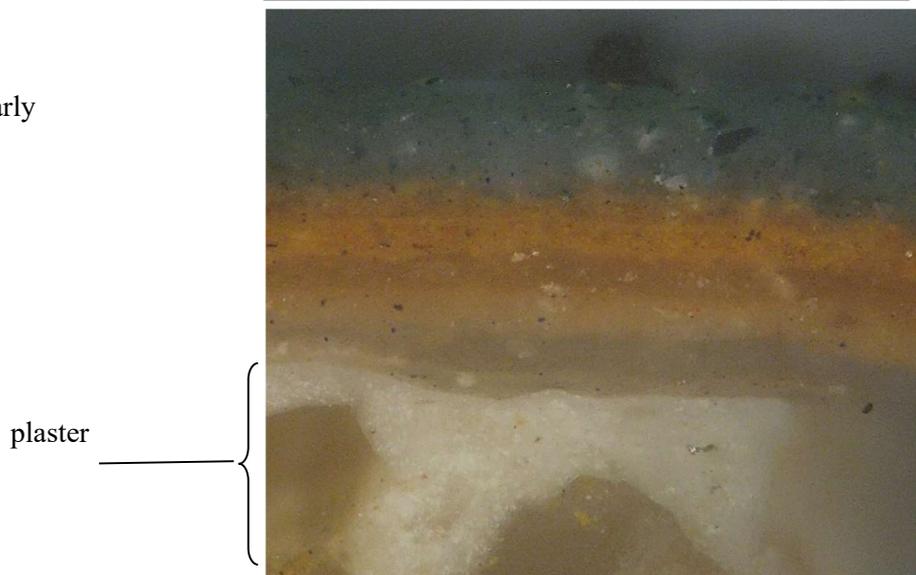
SAMPLE D4

Showing more of the early
buff distempers

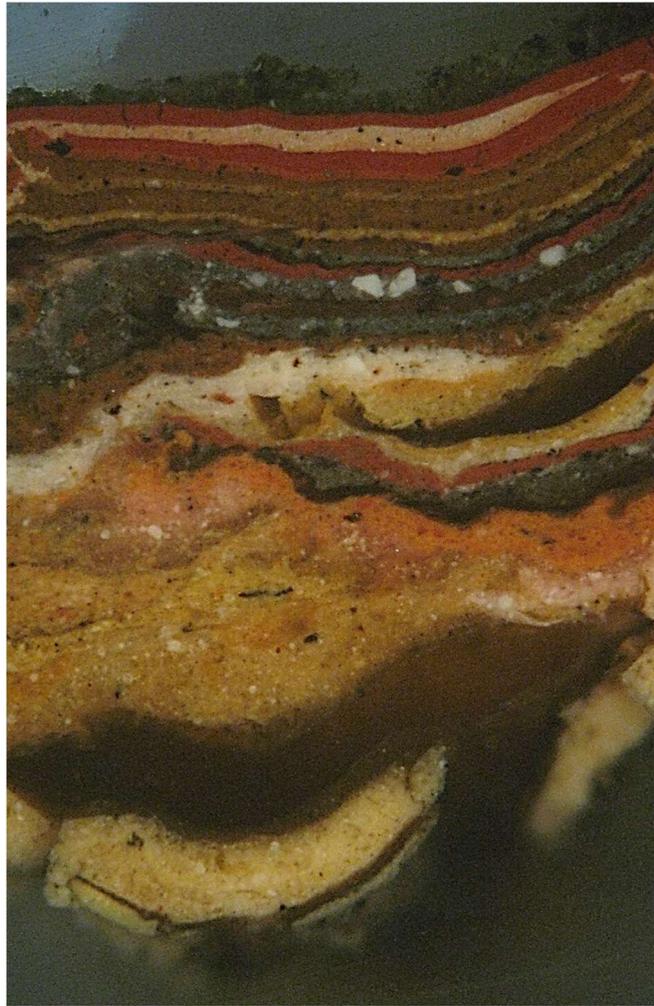
Showing that the door has sometimes been painted a plain brown, and sometimes grained.

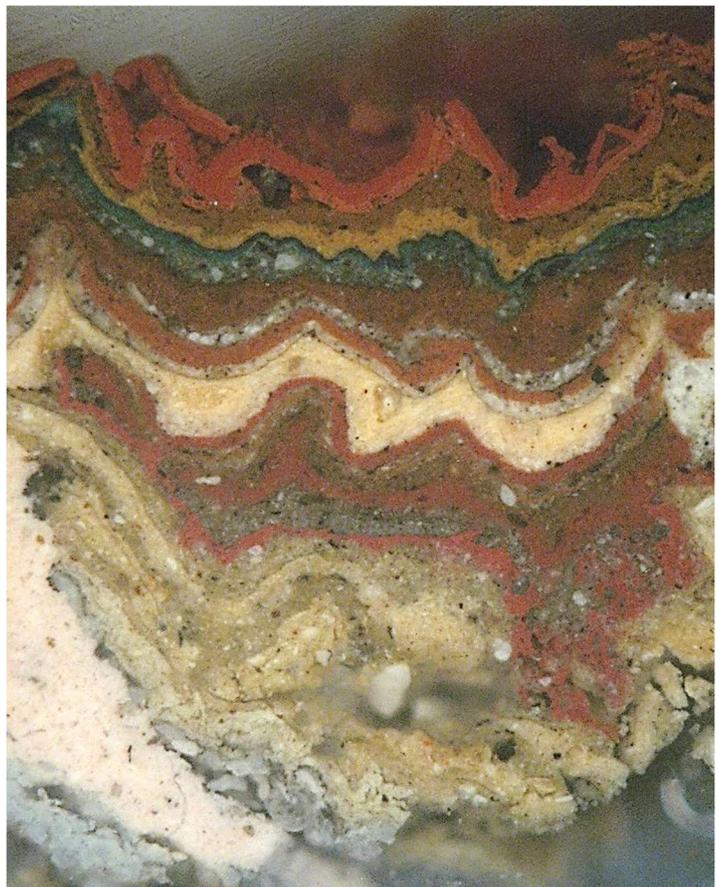
SAMPLE Ex7

The layers are distorted, partly as a result of lead salts, but comparing this with Ex4 above, we can see that the hopper has been painted as often as the fascia board, and with the same paints.

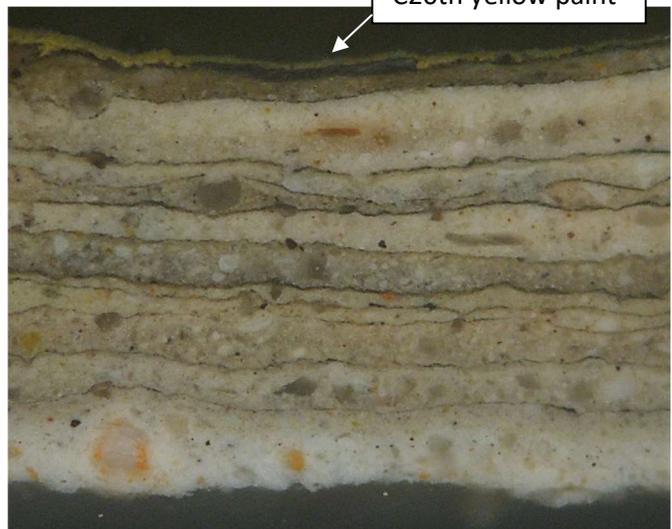
SAMPLE Ex.11

The later layers seen in Sample 12 above are missing.

C20th yellow paint
